# Case Study

V & A Waterfront  
Cape Town, South Africa

Yacht Basin Biological Remediation of poor water quality

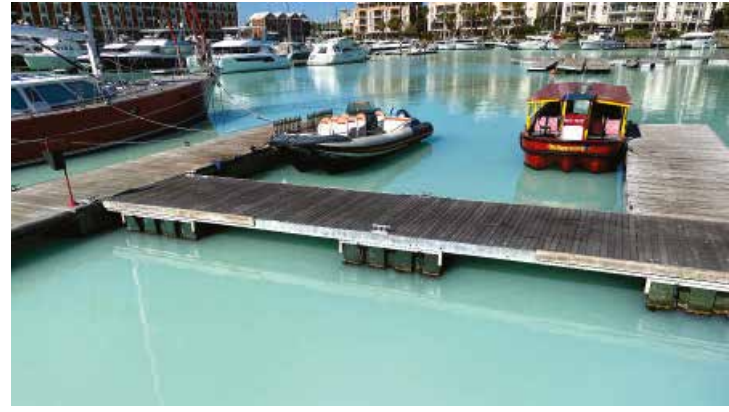
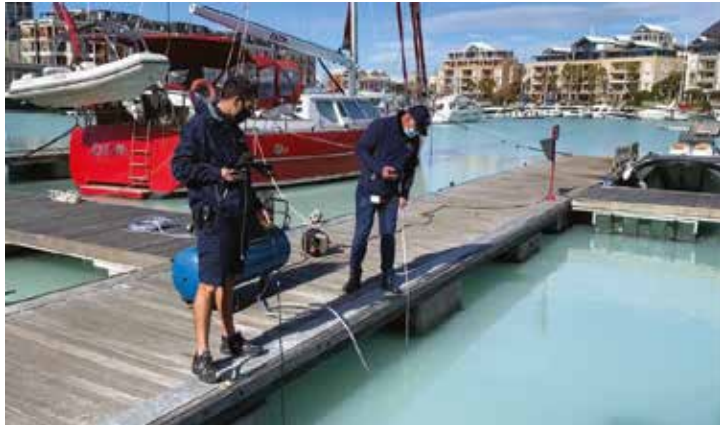
- **Large fish shoal** chased into the basin by whales outside the harbor
- All the **oxygen was depleted** very quickly
- All **fish died** in the basin
- Degradation of the fish result in oxygen dropping to **dissolved oxygen level of 2%**
- Any fish coming into the basin died immediately i.e. **Ocean Sunfish**

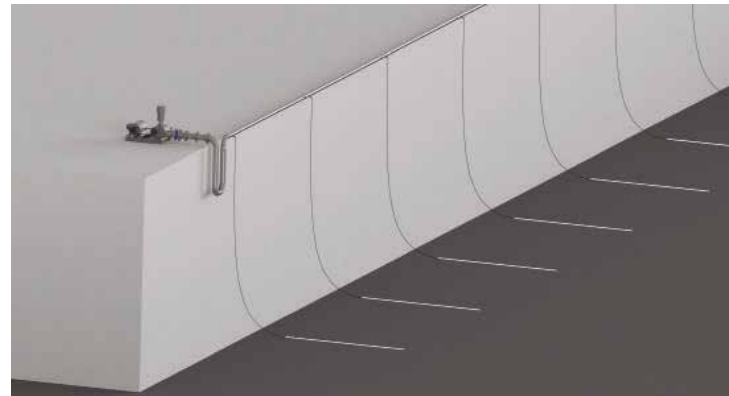
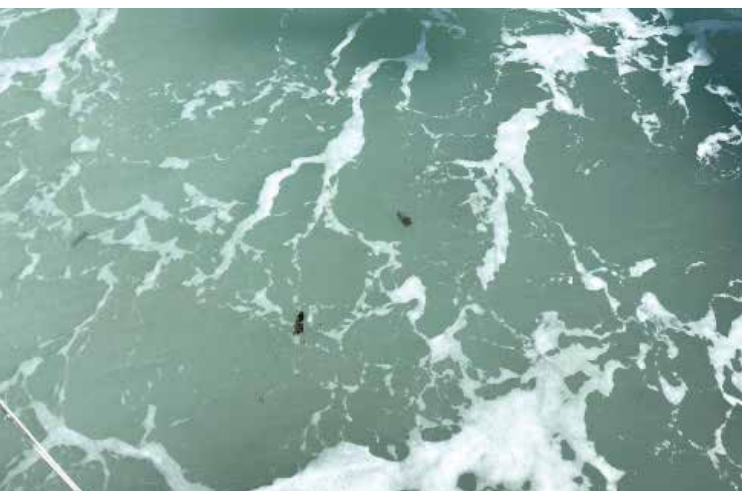
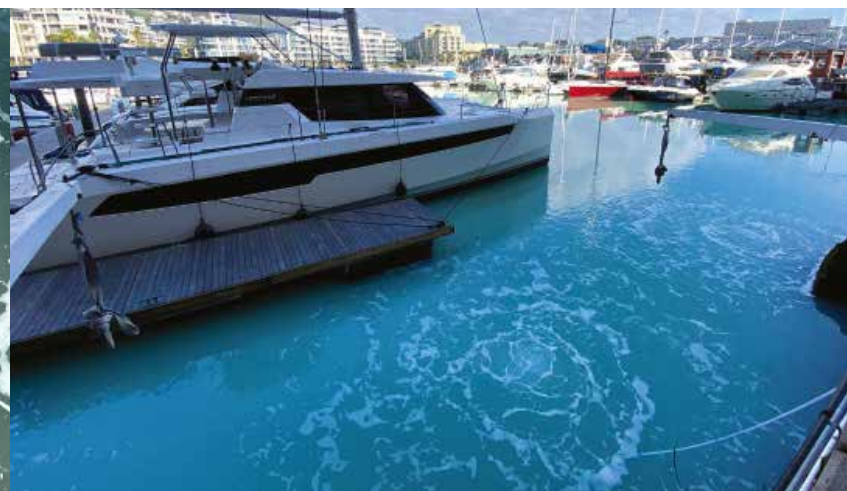
- **75 Dryden Aqua high efficiency air diffusers**
- **10m<sup>3</sup>/hr** of air per diffuser @ 3m depth
- Distributed around the basin, fed by **two roots blowers**
- Moving a total of **750m<sup>3</sup>/hr** of water to increase mixing - much large area was improved that we thought would happen, showing the extent of the water movement
- Oxygen transfer of **1650kg O<sup>2</sup> per day**

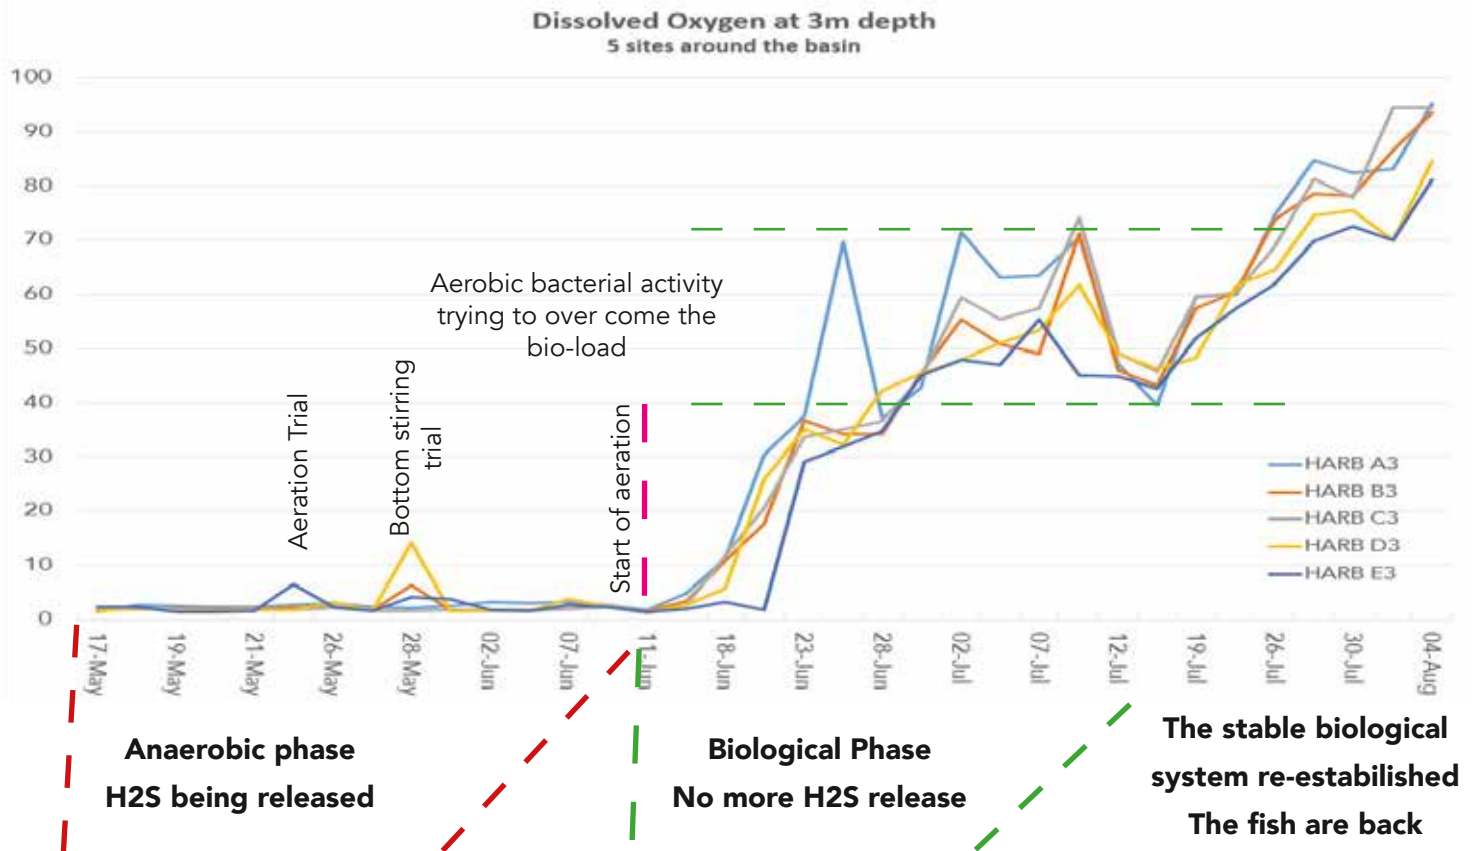
The below graph shows the entire process from very low DO levels (2%) to greater than 80%, where a stable and healthy environment was again achieved. As with the DO, the overall pH climbed from its lowest at 7.4 to over 8, which is a normal pH for the water around Cape Town.

Bacterial samples were taken throughout the process and the advent of Hydrogen Sulphide producing bacteria quickly diminished once aeration was started, with aerobic bacteria taking its place to decompose the organics sitting on the sea bed.

**Table: Summary of the change in DO parameters for the deepest sampling points**

May 2021			Sept 2021		
	Sal (ppt)	pH	DO (%)	Sal (ppt)	pH	DO (%)
Harb A3	35.66	7.53	1.5	35.95	8.04	87.3
Harb B3	35.66	7.56	1.8	35.95	8.06	89
Harb C3	35.66	7.55	1.7	35.94	8.07	88.1
Harb D3	35.66	7.56	1.7	35.94	8.07	86.6
Harb E3	35.65	7.63	2.3	35.93	8.06	81.1
